# Manhole Inspection Summary

Manhole # S59K\_\_014MH

**Location** Address: **4500 fait ave**

Cross Street: **s lehigh st**

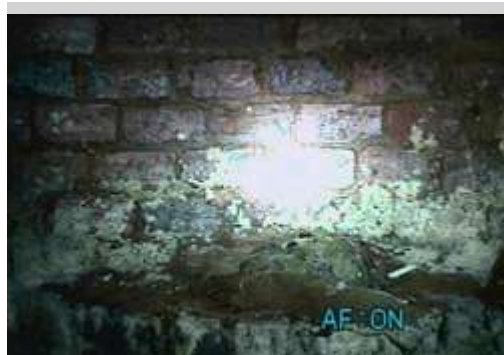
Defect 4

channel debris

bench debris

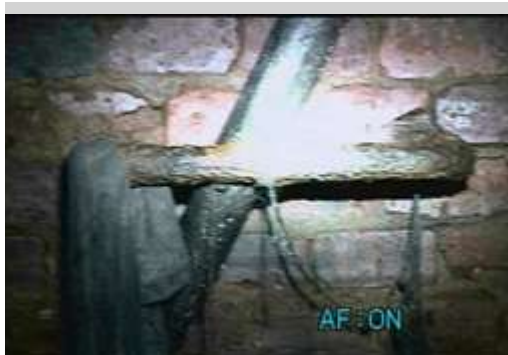
Defect 3

☒ **Evidence Of Surcharge** Depth: **15.** (ft.) ☐ Active Surcharge Present

surcharge evidence

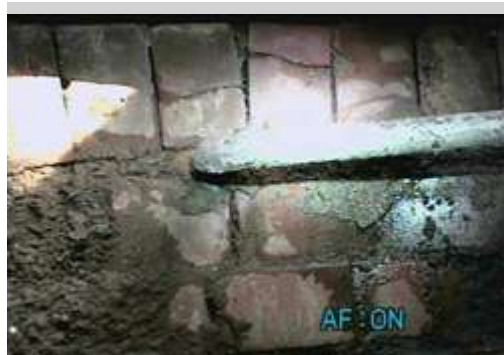
Defect 2

Chimney loose bricks, frame adj

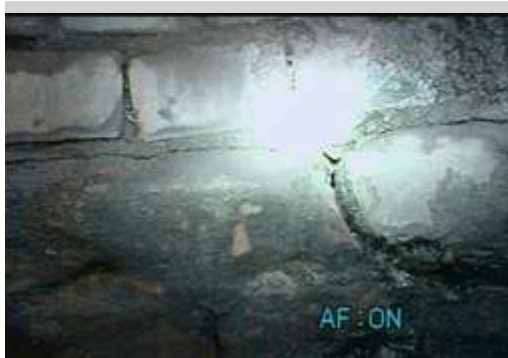
Defect 1

Condition: ☐ Sound ☒ **Cracked** ☐ Root Intrusion ☐ Loose Brick ☐ Deteriorated

crack in corbel

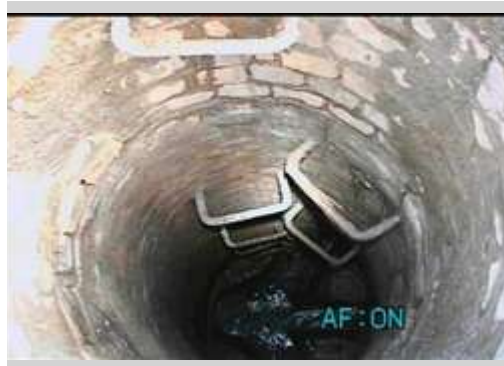
Count: **11** Missing: **0** ☒ **Corroded**

steps

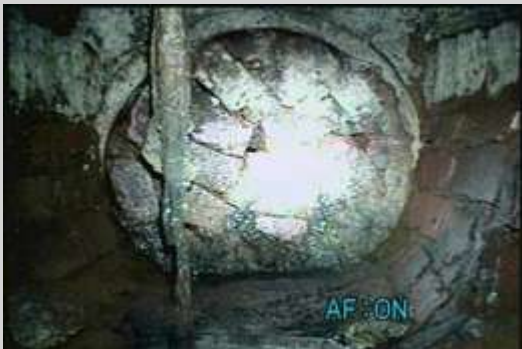
3 O'Clock Inflow

sealed

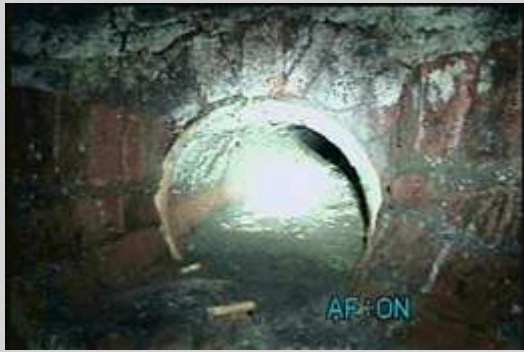
6 O'Clock Inflow

sealed
